## **CRANNAFORD PLAY PARK – PATH REMEDIATION**

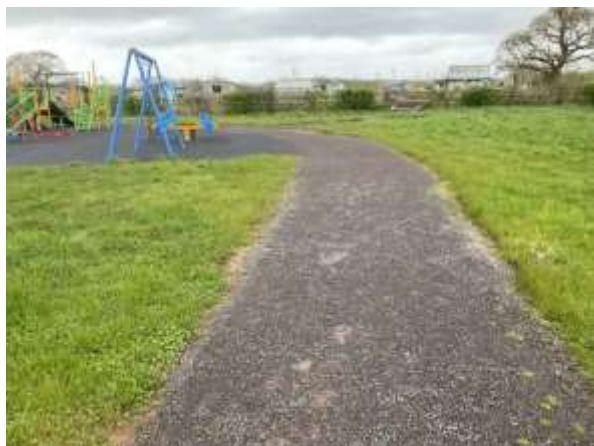
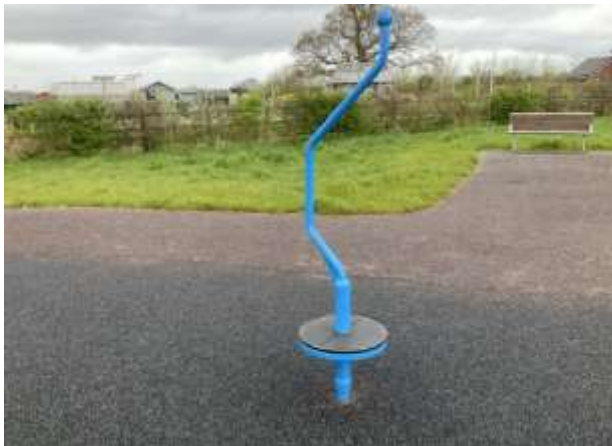
As part of the Officer's Operational Play Park Inspection Training, the trainer highlighted an issue with the edge of the wet pour safer surface where it meets the perimeter path and demonstrated that it was no longer bonded to the ground. The wet pour could be lifted which would result in significant damage to the play area surface and present potential risk as a trip hazard.

Further advice was sought from the Council's Ground Maintenance and Landscaping Contractor to see if there were alternative options for consideration. The landscaping Contractor confirmed that wet pour does retreat/shrink over time leaving a void between two distinct surfaces such as the path or tarmac. Grass is an alternative method to minimise the consequential shrinkage as the grass will creep and fill the void and reduce the issue of a potential trip hazard. The Committee will be aware that grass can present its own issues particularly following heavy rainfall but this is measured with the lower footfall

Information has been sought from the Play Park Contractor who installed the play area and safer surface in 2022. The original installation team no longer works for the firm and a site meeting was held with the new representatives. The contractor recommended the installation of a pin kerb to remediate the edge of the wet pour and advised against doing nothing. The pin kerb would provide a bonded edge to secure the wet pour surface. An explanation together with a quotation is annexed to this report at Appendix A and B.

The contractor suggested that the middle section of the perimeter path, defined as the area between the two sets of seating, to be grassed to the edge of the wet pour. The design would allow for the gravel path to remain at both entrances up to and including the seating area thereby retaining an all-weather surface to access the play area. A quotation is annexed to this report at Appendix C.

- 1. To approve the remediation of the interior section of perimeter footpath at Crannaford Play Park.**
- 2. To recommend to Council to instruct the Council's Ground Maintenance and Landscaping Contractor to replace the existing perimeter path to with grass as per quotation for £5,368.00**
